Technical Report No.: 64.666.19.056.03 Date: 2019-12-11

Test subject: Product: Safety rope

Model/Type: RSR1235A

Test specification: Loading test refer to BGV C1 and DGUV Information 215-313(formerly

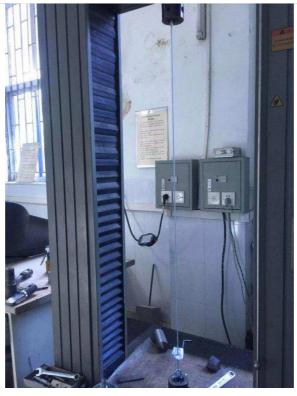
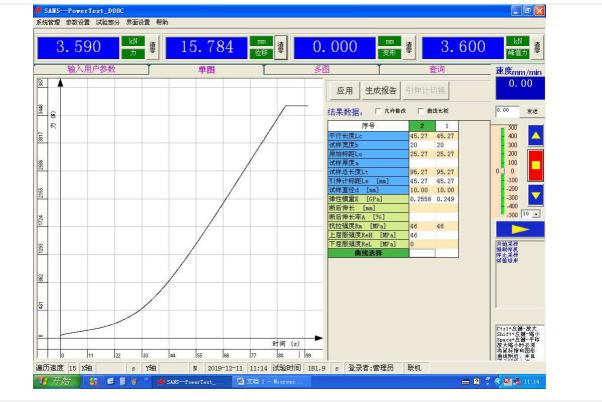
Appendix: Test Photo(s)

The minimum failure force in straight pull shall be such that it will sustain a force equivalent to 10 times the load-bearing capacity (WLL) refer to BGV C1 and DGUV Information 215-313(formerly BGI 810-3).

Requried test force: 3500 N

Results: Pass; no breakage after test.
